TOYOTA Technical Service BULLETIN

WINDSHIELD WIND NOISE

'05 Tacoma

NV/006-07

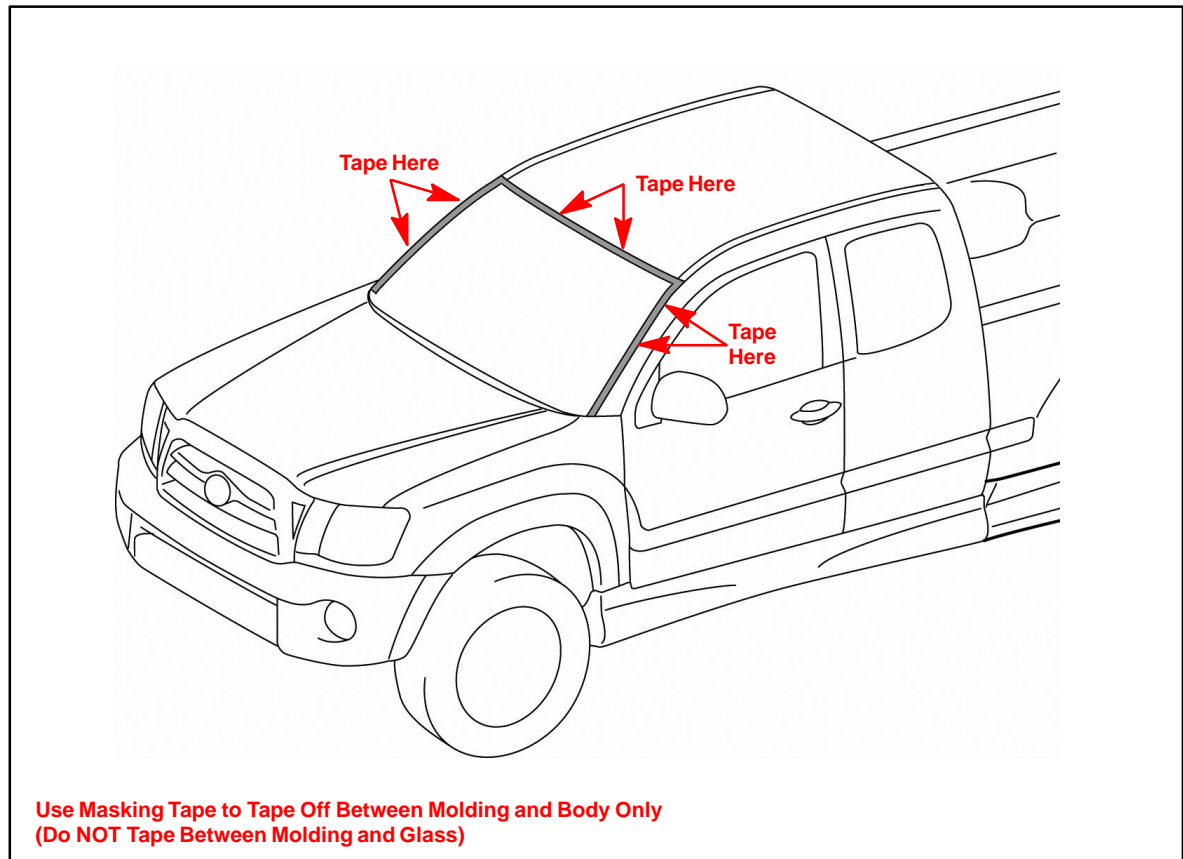
Introduction Some customers may experience a wind noise that sounds like a “buzz” or “reed vibration” sound from the windshield area. This condition may be the result of wind (air) pressure creating rapid oscillations of the rubber windshield molding, which produces a high-pitched buzzing or whistling sound.

1. Apply 2" wide masking tape over the rubber windshield molding where it meets the body up both A-pillar and the roof (bridge over the edge of the molding where it lays against the A-pillar and the roof). Refer to the illustration below.

Do NOT add tape between the rubber molding and the windshield glass.

2. Once the masking tape is in place, test drive the vehicle at highway speeds (above 50 mph [80 km/h]), by traveling in both directions on the highway (to compensate for any crosswinds).
 - If the tape application between the molding and the body eliminates the noise, proceed to the "Repair Procedure" section in this TSB.
 - If the noise is still present, apply tape to seal additional components until the source location of the noise is identified.
